TECHNICAL SHEET #11

Remedial Practice to Safeguard Face Bricks & Mortar Joints from Sea Spray Attack

REMEDIAL PRACTICE TO SAFEGUARD FACE BRICKS & MORTAR JOINTS FROM SEA SPRAY ATTACK

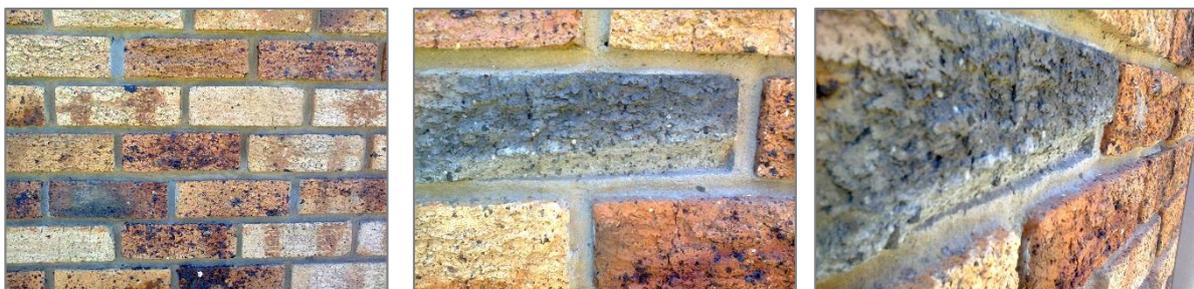
A water based sealant had been applied to the external face brickwork some years previously. The objective had been to protect the face brickwork from the harshness of the coastal zone weather. The owner was later told that this sealant prevents the walls from “breathing” since it forms a film on the surface, and wanted to know if this sealant is going to cause problems in the future and does it need to be removed.

“Looking at the photos of the brickwork, there is no significant deterioration of the external economic face bricks over the 26 years of exposure to what must be a sea spray zone in a coastal area.

“Overall the quality of the bricks and brickwork workmanship looks good. In my experience any face bricks not exhibiting any signs of flaking/disintegration after 26 years of exposure in a coastal zone are unlikely to fail in the future.

“What the photos show is typical of sodium chloride, sea spray zone attack where the dissolved sodium chloride crystallises out inside the pore structure of the fired clay face brick and progressively breaks down the pore structure just below the surface of the brick due to the salt crystals forming and imposing significant pressures on the pore structure.

“Ideally, external face bricks DO need to allow liquid water, with soluble salts present, to come to the surface and allow the salt crystals to deposit on the surface i.e. brickwork is allowed to breathe.

“The application of a water based sealant, whilst not desirable, might not be a significant factor in the deterioration of individual face bricks. I would recommend that the remedial work of replacing the low number of flaking face bricks be carried out, and observe the face bricks performance over time,

“If there are less than 200 external face bricks affected, I would recommend that a suitably reputable local building contractor be requested to quote on the following:

- Either remove the remaining portion of flaking brick, or cut a suitable brick slip to fit into the volume available.
- Replace with a suitably matched well burnt economic face brick sourced from a local brick maker or builders merchant.
- Re-point with a 1:3 mortar mix and a well-polished half round joint.

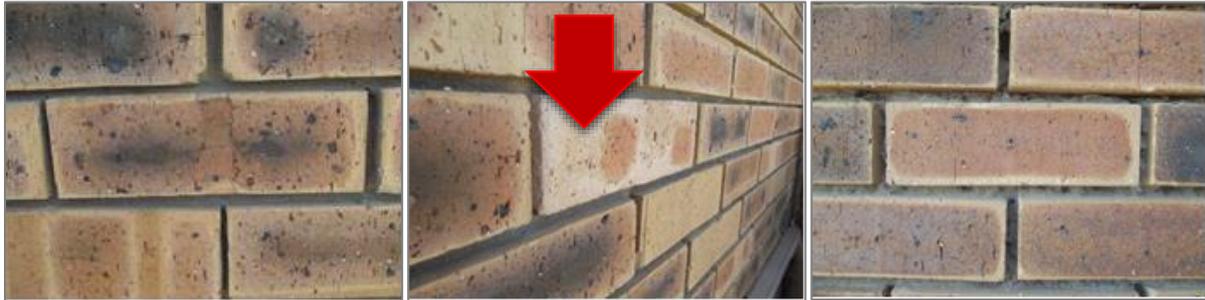
A sea facing house built 15 years ago, some 300 metres from the beach with a SE elevation is situated in the most severe of sea spray zones, Exposure Zone 4. Inspection of the exterior walling showed that the brickwork and mortar joints had mostly performed well considering 15 years of rigorous exposure, taking into account the following surface deterioration experienced:

The extent of surface weathering of the face bricks was estimated at 2-3% which is relatively low considering the extreme sea spray conditions.

The degree of surface spalling caused by consistent salt water exposure was estimated at less than 2 mm. This is considered to be relatively low for 15 years exposure.

Disintegration of the mortar joints and 2-3% incidence of face bricks with surface disintegration is generally confined to the weather and sea facing SE elevation.

1. Providing that the elevations (other than the SE elevation) are visually and aesthetically acceptable, remedial work could be confined to the SE elevation.
2. A suitably well fired clay face brick, that matches up to the colour and texture of the existing face brickwork needs to be identified. See www.claybrick.org for details of Clay Brick manufacturers in your area.
3. Identify those face bricks with more than 20% surface deterioration, to have the face chiselled back by 25 mm with a 20 mm matching brick slip mortared into place. It is likely that bricks exhibiting less than 20% surface spalling after 15 years will show negligible deterioration in the future. Alternatively, if such bricks are at a window/door reveal or corner, carefully remove the whole brick and mortar and install a replacement brick.

4. All the SE elevation horizontal and vertical square raked joint mortar joints, not suited to Exposure Zone 4, will have to be chiselled/raked back by 20-25 mm and re-pointed to cover the deteriorating joints, so as to avoid a patchy effect on the face brickwork due to the replacement face brick slips. In the event that the mortar joint deterioration appears more extensive than the face brick spalling, it must be attended to.
5. The re-pointing mortar must be a Class 1 mortar, 1 part cement : 4 parts clean, well graded mortar sand.
6. The mortar joint profile must be either a polished weather struck joint or half round well-polished bucket handle profile, so as to create a low porosity joint that minimises future ingress of salt spray, thereby protecting both the joints and face bricks.
