TECHNICAL NOTE #11

Remedial Practice to Safeguard Face Bricks & Mortar Joints from Sea Spray Attack

CASE STUDY 1

CASE STUDY 2:

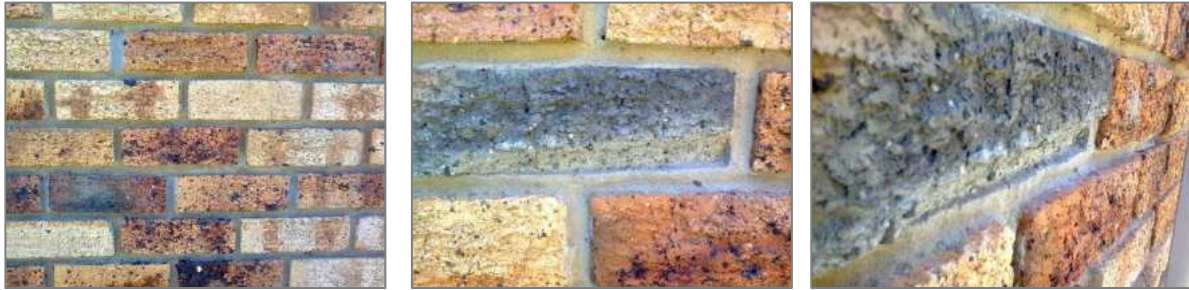
A water based sealant had been applied to the external face brickwork some years previously. The objective had been to protect the face brickwork from the harshness of the coastal zone weather. The owner was later told that this sealant prevents the walls from "breathing" since it forms a film on the surface, and wanted to know if this sealant is going to cause problems in the future and does it need to be removed.

“Looking at the photos of the brickwork, there is no significant deterioration of the external economic face bricks over the 26 years of exposure to what must be a sea spray zone in a coastal area.

“Overall the quality of the bricks and brickwork workmanship looks good. In my experience any face bricks not exhibiting any signs of flaking/disintegration after 26 years of exposure in a coastal zone are unlikely to fail in the future.

“What the photos show is typical of sodium chloride, sea spray zone attack where the dissolved sodium chloride crystallises ~~out~~ inside the pore structure of the fired clay face brick and progressively breaks down the pore structure just below the surface of the brick due to the salt crystals forming and imposing significant pressures on the pore structure.

“The application of a water-based sealant, whilst not desirable, might in this instance not be a significant factor in the deterioration of individual face bricks. I would recommend that the remedial work of replacing the low number of flaking face bricks be carried out, and observe the face bricks performance over time,

“If there are less than 200 external face bricks affected, I would recommend that a suitably reputable local building contractor be requested to quote on the following:

- Either remove the remaining portion of flaking brick and replace with a matching brick, or cut a suitable brick slip [face brick surface of a matching brick cut to a depth of 20mm] to fit into the volume available.
- Replace with a suitably matched well burnt face brick sourced from a local brick maker or builders merchant.
- Re-point with a 1:3 mortar mix and a well-polished half round joint.

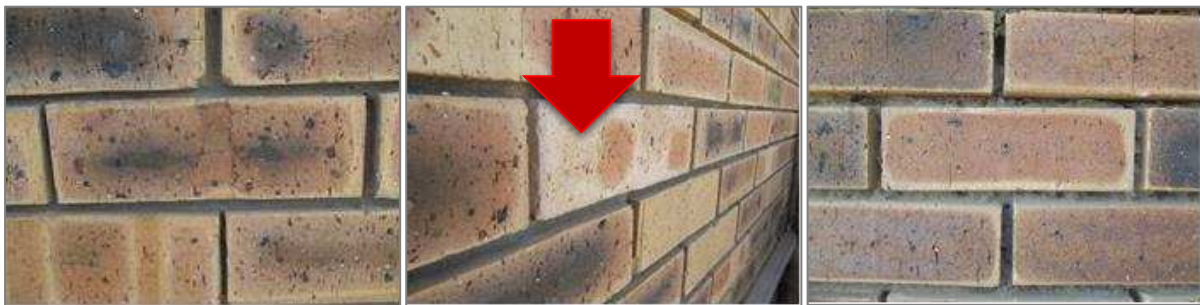
A sea facing house built 15 years ago, some 300 metres from the beach with a SE elevation is situated in the most severe of sea spray zones, Exposure Zone 4. Inspection of the exterior walling showed that the brickwork and mortar joints had mostly performed well considering 15 years of rigorous exposure, taking into account the following surface deterioration experienced:

The extent of surface weathering of the face bricks was estimated at 2-3% which is relatively low considering the extreme sea spray conditions.

The degree of surface spalling caused by consistent salt water exposure was estimated at less than 2 mm. This is considered to be relatively low for 15 years exposure.

Disintegration of the mortar joints and 2-3% incidence of face bricks with surface disintegration is generally confined to the weather and sea facing SE elevation.

1. Providing that the elevations (other than the SE elevation) are visually and aesthetically acceptable, remedial work could be confined to the SE elevation.

2. A suitably well fired clay face brick, that matches up to the colour and texture of the existing face brickwork needs to be identified. See www.claybrick.org for details of Clay Brick manufacturers in your area.

3. Identify those face bricks with more than 20% surface deterioration, to have the face chiselled back by 25 mm with a 20 mm matching brick slip mortared into place. It is likely that bricks exhibiting less than 20% surface spalling after 15 years will show negligible deterioration in the future. Alternatively, if such bricks are at a window/door reveal or corner, carefully remove the whole brick and mortar and install a replacement brick.

4. All the SE elevation horizontal and vertical square raked joint mortar joints, not suited to Exposure Zone 4, will have to be chiselled/raked back by 20-25 mm and re-pointed to cover the deteriorating joints, so as to avoid a patchy effect on the face brickwork due to the replacement face brick slips. In the event that the mortar joint deterioration appears more extensive than the face brick spalling, it must be attended to.

5. The re-pointing mortar must be a Class 1 mortar, 1 part cement : 4 parts clean, well graded mortar sand.
6. The mortar joint profile must be either a polished weather struck joint or half round well-polished bucket handle profile, so as to create a low porosity joint that minimises future ingress of salt spray, thereby protecting both the joints and face bricks.
