TECHNICAL NOTE #03

Condensation & Mould in affordable housing in the Western & Southern Cape

A review of reports on condensation and mould problems found in affordable housing in the Western and Southern Cape winter rainfall regions of South Africa. These locations often experience severe condensation on the inside surface building shell which results in mould growth and other health issues.

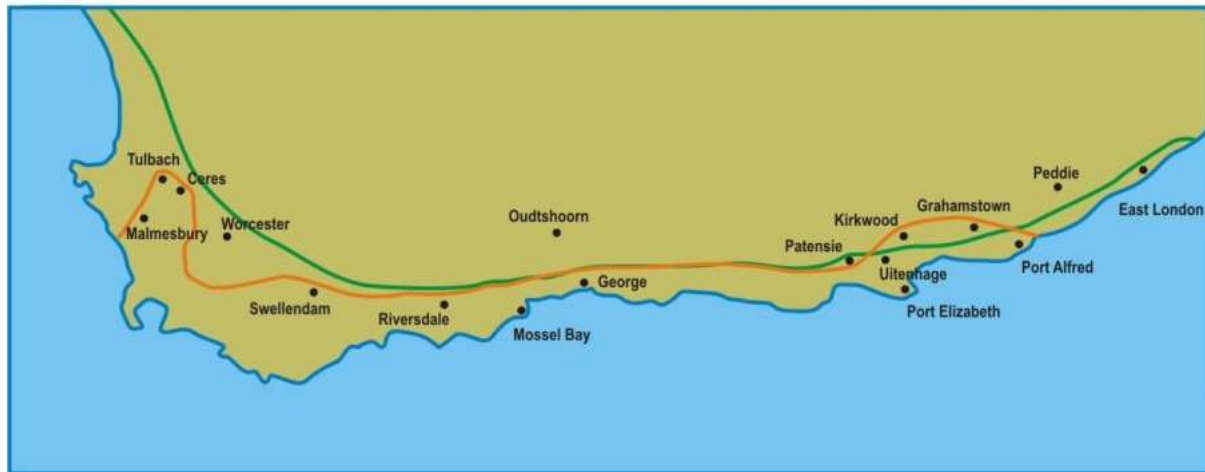
CONDENSATION BOUNDARY AS PER TEMMI REPORT

Verification of the New Condensation Boundary
Old Condensation Boundary
