TECHNICAL NOTE #36

Durable clay brick – protecting property from fire and flood

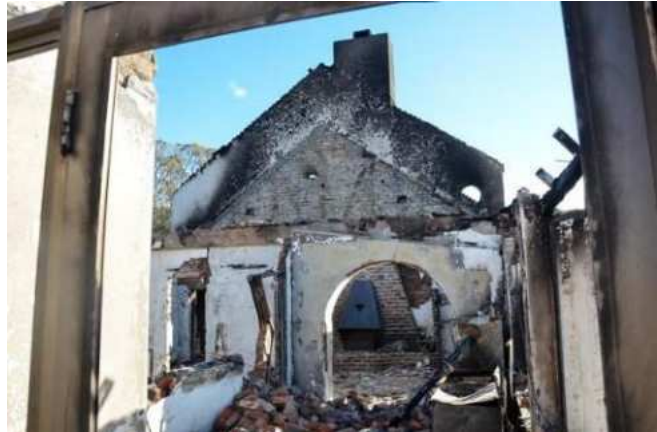
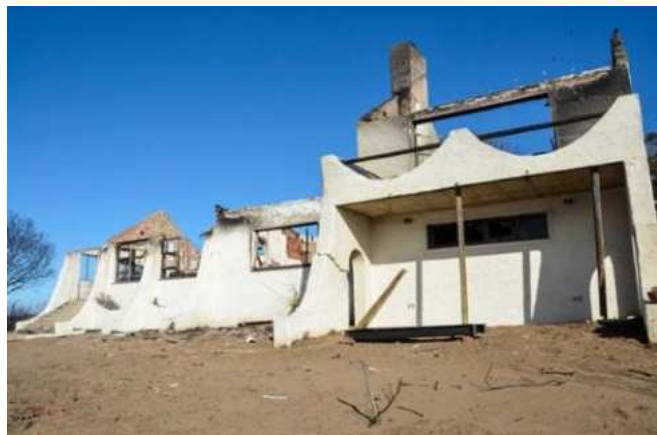
Properties damaged by the Knysna fire in 2017

Most clay bricks are fired to at least 1000 degree Celsius, and even if higher external temperatures were to occur, the clay bricks would not lose their integrity. A more important factor in assessing the likelihood of structural damage is the rate of travel of the fire. The speed of the recent Knysna fires was estimated at 60 km/h – or 1 km per minute – due to severe wind driven conditions.

This gives a fire transit time of 10-15 minutes. The inherent high thermal resistance of clay brick and mortar masonry would significantly retard the flow of heat into the body of both bricks and mortar. This will have helped to reduce the rate of temperature build up to below that which damage may occur.

Consequently, it is unlikely that significant reductions in the structural strength of the clay brick masonry will have occurred. The reduced rate of heat penetration is also unlikely to have caused significant reductions in the strength of steel ties or brick force.

What is clear from many photographs, is that for most properties, only the masonry walls have been left standing (although clearly damaged). For those houses on the periphery of the blaze, what is the probability that brick walls that survived the blaze remain structurally sound?*

****After any fire, if the resident sees any visible signs of masonry cracking, wracking of the brick work or separation between adjoining wall elevations, the services of a structural engineer should be sought.***

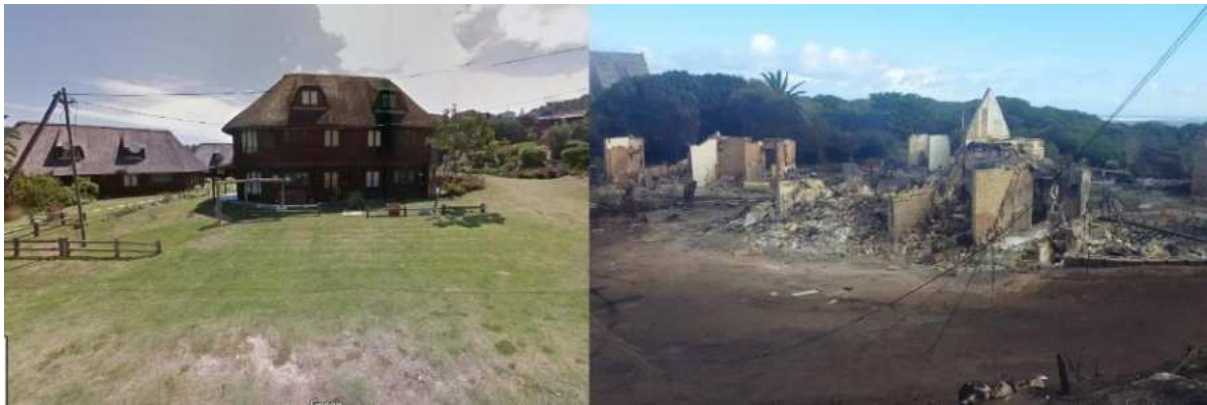
Thatched houses (few internal walls, low external walls, wooden floors and beams.)
Highest risk

Small corrugated iron and wooden roofed dwellings with few internal walls.

Steel and Timber frame housing (if the timber is treated regularly and there are interior fire-resistant walls.)

40 m² dwellings constructed of 140 mm hollow concrete blocks.

Cement slab dwellings with interior walls and non-structural windows (large glass windows carry a high explosion risk)

220 mm Solid clay brick masonry house (Lowest risk)

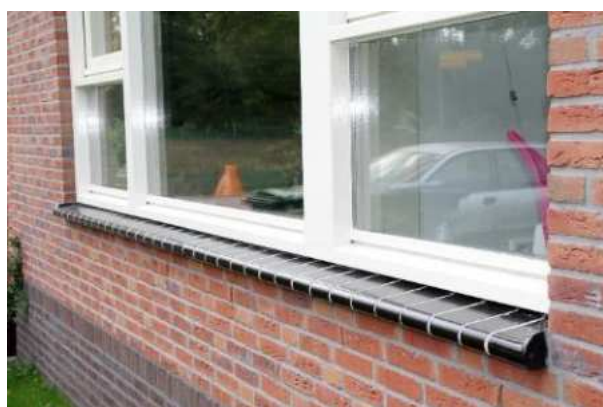
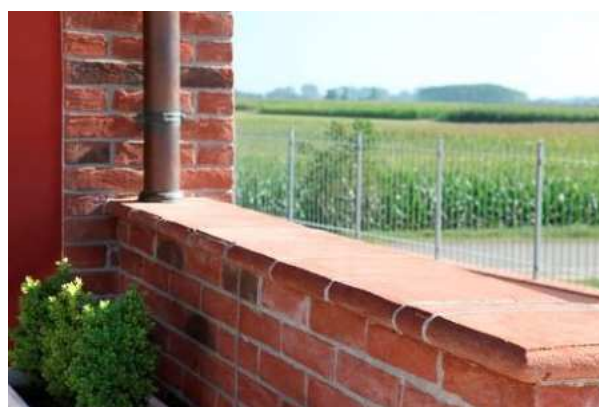
Copings provided at the top of parapet walls, free-standing walls and retaining walls will minimise the risk of saturation of the brickwork. A coping sheds rainwater falling on it clear of all exposed faces of the walling it is designed to protect. The drip edge of the throating should be at least 40mm from the face of the wall.

A continuous sheet of damp proof course should be provided immediately beneath jointed copings and cappings (which do not extend), in order to prevent downwards percolation of water into the wall should the joints fail.
